## FAULT CLASSIFICATION & TEST SELECTION

### Resisted Short to Ground

#### Ford Five Hundred No HVAC & Lack of Power

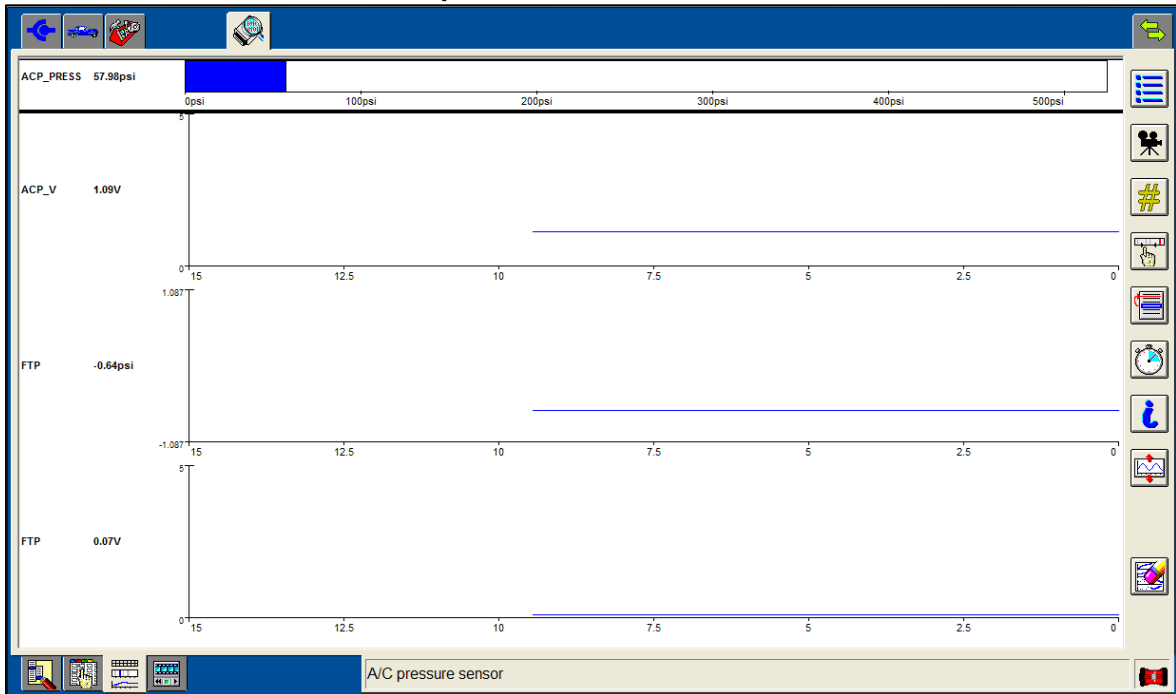
#### A/C Pressure Sensor PID Example

Since the first thing to do is verify that a fault is current, a quick check of a few PIDs indicated that there were unexpected values for the sensors related to most of the codes. In the example below, the A/C Pressure (ACP) sensor showed only 58 PSI (1.09 Volts), which is far less than the actual pressure shown during the recharge.

The A/C pressure sensor PID showed a lower pressure than the actual system pressure. And thanks to the first technician's 2 mistakes, we really knew that the pressure was correct and that the pressure sensor was not the problem (because both the old and new showed the same low pressure).

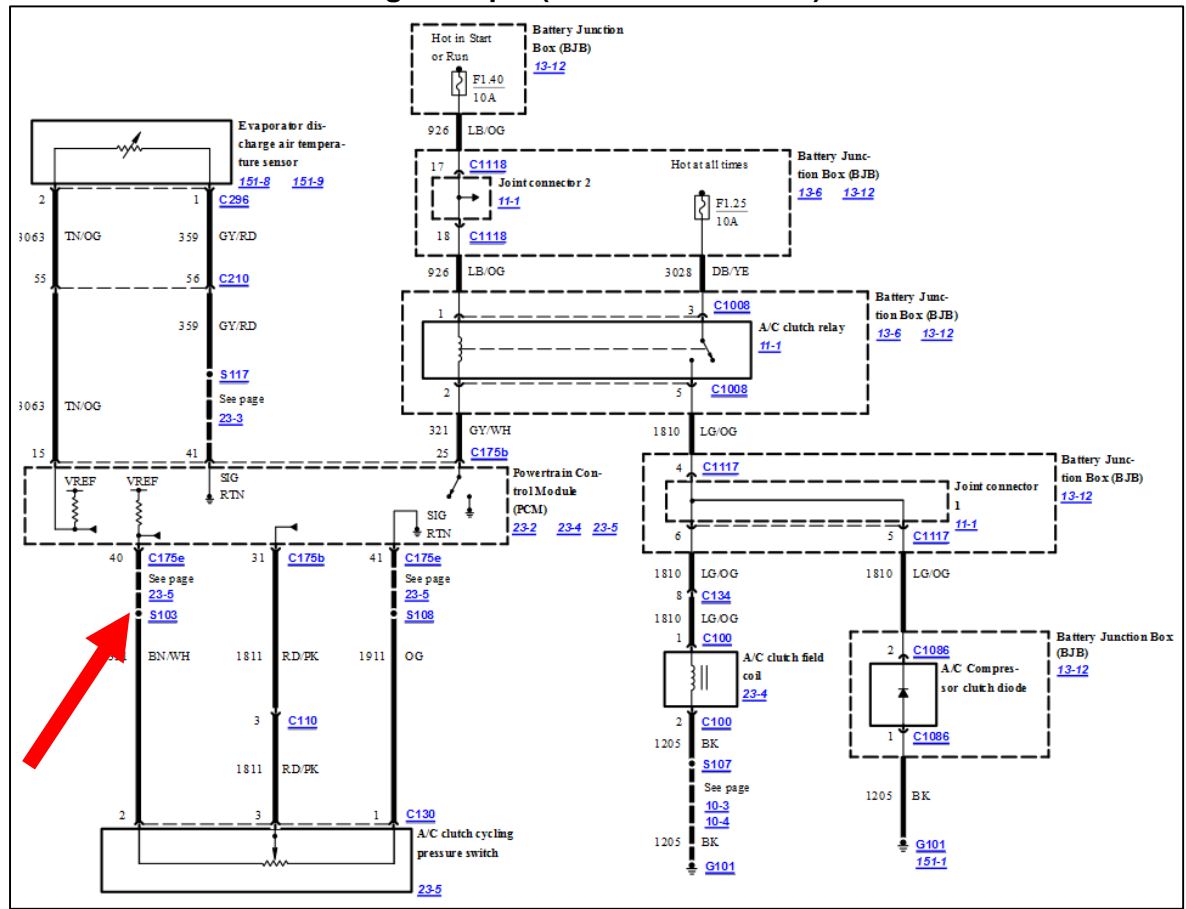
### A/C Pressure Sensor Wiring Example (Arrow Shows S103)

Time to test reference voltage. The wiring diagrams were checked to see if there was a splice or other junction that connected many or all of the 5 Volt circuits. S103 in the diagram below indicates that the VREF is shared with something else. Since the source of the VREF was the PCM, the PCM wiring diagrams were also checked to find the rest of the S103 circuits. The diagrams on the next page show that this same Brown/White wire powers the EGR valve (position sensor), A/C pressure sensor, and FRP sensor via S103.

The diagrams don't prove that this 5 Volt VREF circuit powers the MAP sensor or FTP sensor, which also have codes, but it's possible that all VREF circuits are connected inside of the PCM. During this diagnosis, we already had 3 codes relating to 3 sensors that absolutely shared a VREF circuit, so that's was a good place to start...

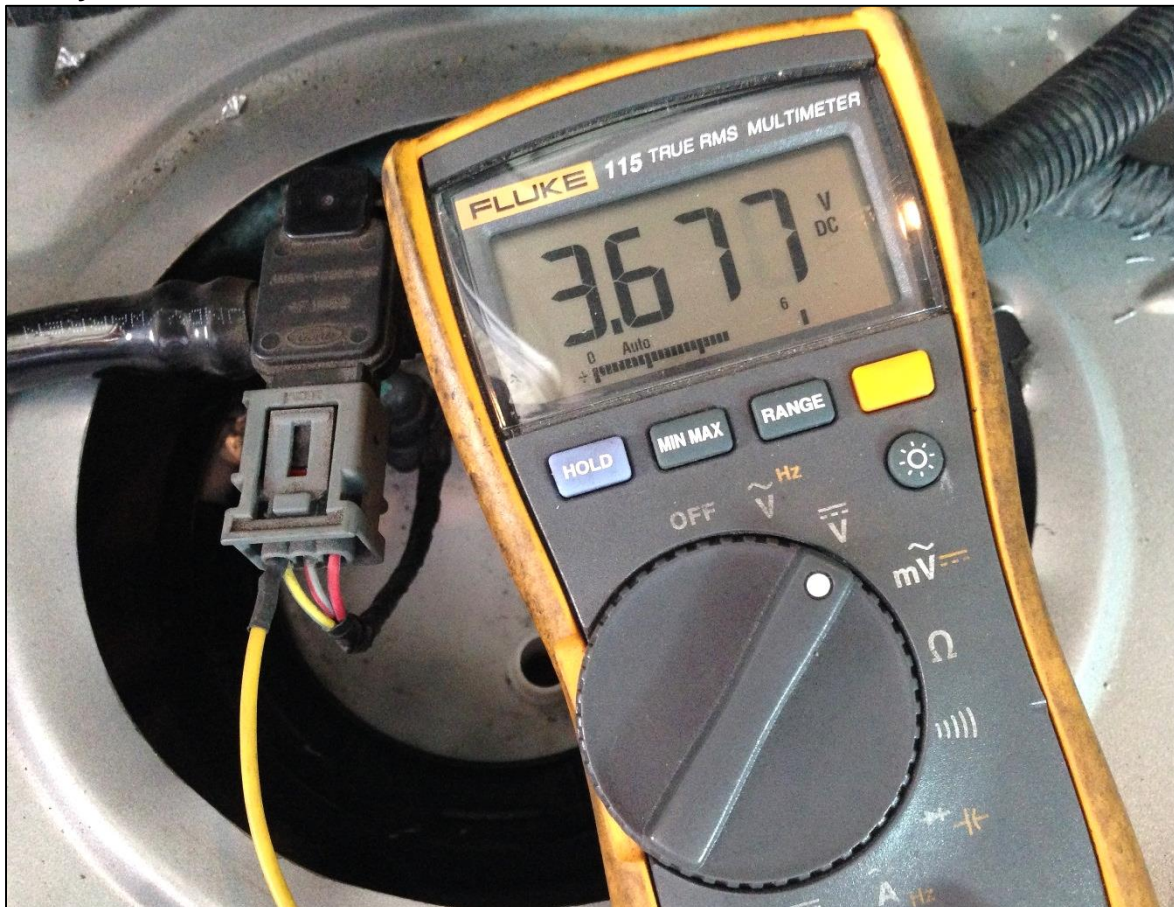
#### Faulty VREF Test @ FTP Sensor Connector

The best test for VREF is to pick the easiest sensor to access and simply unplug it and measure VREF. The A/C pressure sensor was unplugged, and the VREF terminal showed 3.7 Volts instead of 5 Volts. With that 1.3 Volt error, all 5 Volt reference sensors would still be in range, but would return an incorrect value for the give conditions. With the DVOM still connected, the EGR valve connector and FRP sensor connector were disconnected. VREF remained at 3.7 Volts.

The wiring diagrams do not indicate whether or not the VREF to other sensors is shared inside of the PCM. However, there were also codes for the FTP sensor and MAP sensor, so those sensors were disconnected too. There's no MAP sensor, but tracing the MAP terminal from the PCM indicated that it was integrated into the EGR assembly. When disconnected, the VREF at the A/C pressure sensor was still 3.7 Volts. Many FTP sensors are hard to access, and this is one of the worst – it's part of a plastic tube and can only be accessed with the fuel tank removed (or at least dropped a bit). With the fuel tank lowered, the FTP sensor and tube were 'flopped' over near the fuel pump access hole under the rear seat, and the sensor was back probed. No surprise...3.7 Volts.

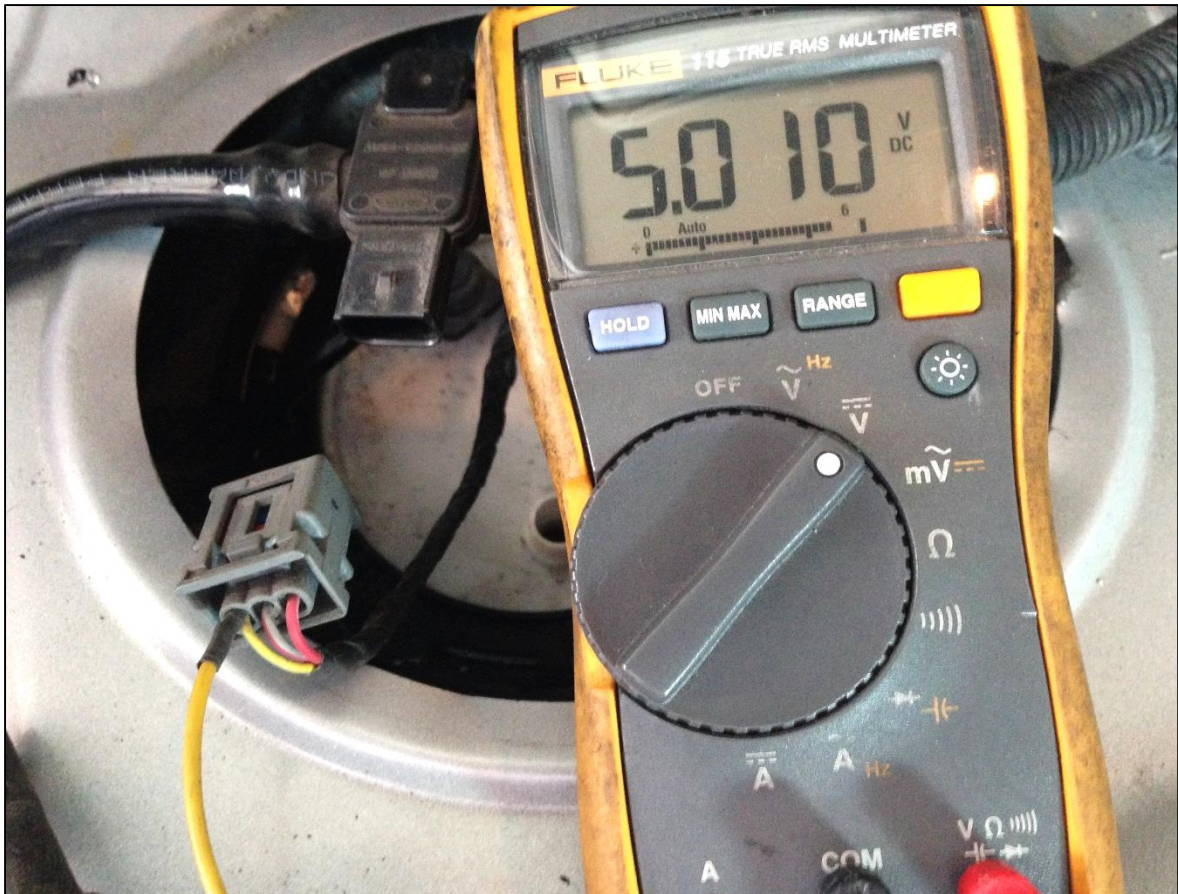
#### VREF Restored!

The FTP sensor was disconnected, and the VREF jumped to 5 Volts at the FTP connector as well as at the A/C pressure sensor and every other sensor tested. All other sensors were reconnected, and all sensor signal PIDs (including A/C pressure) returned to normal. The FTP sensor was replaced and the vehicle was returned to the customer.

This diagnosis correctly classified the fault as a short in VREF circuit. Diagrams showed the VREF circuits to be in parallel, and while they didn't prove that all VREF circuits in the PCM were shared, the codes made the connections for us. Since VREF wasn't pulled all the way to ground, it was more likely a sensor fault than a wiring fault, but the best tools and tests were the same: Use a DVOM to measure VREF while disconnecting components and harnesses that share it, starting with the most accessible sensors. While the eventual repair included dropping the tank, the diagnostic process worked, so the tank R&R could be sold as a solution, and not an unbillable guess.
