## FAULT CLASSIFICATION & TEST SELECTION

### Resisted Short to Ground

#### Ford Five Hundred No HVAC & Lack of Power

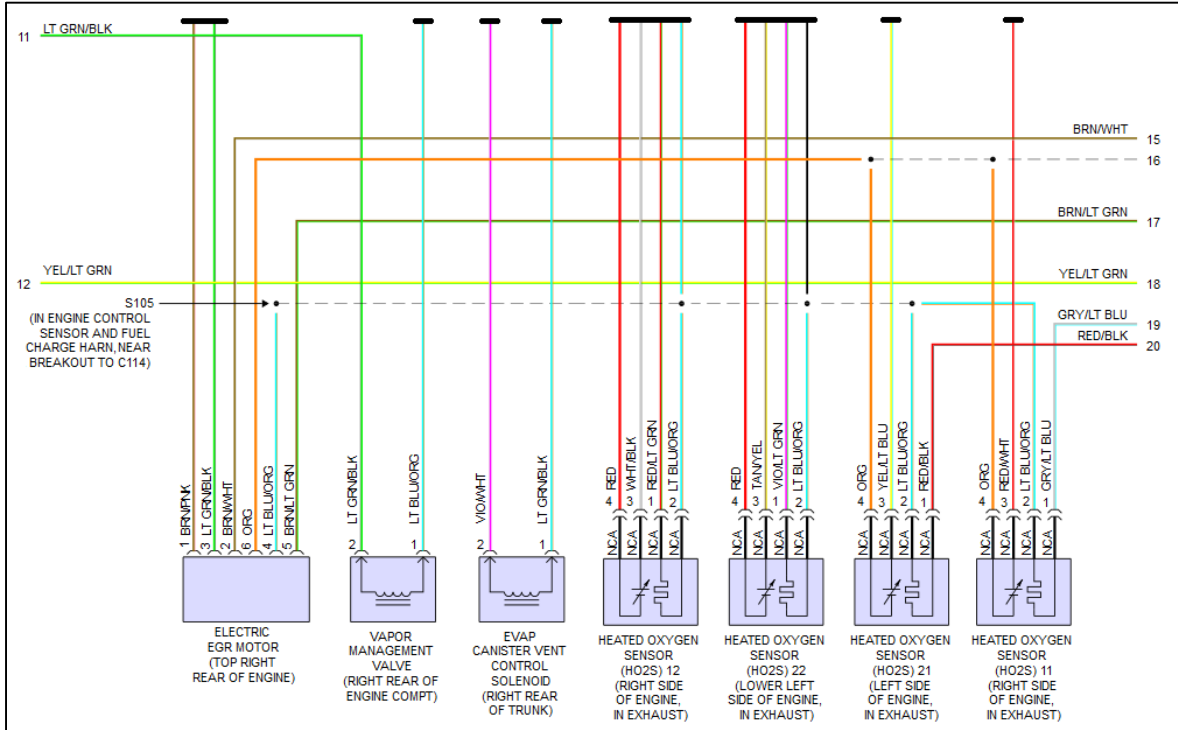
#### PCM Wiring 3 of 5 (Mitchell ProDemand diagram trimmed & resized)

The best test for VREF is to pick the easiest sensor to access and simply unplug it and measure VREF. The A/C pressure sensor was unplugged, and the VREF terminal showed 3.7 Volts instead of 5 Volts. With that 1.3 Volt error, all 5 Volt reference sensors would still be in range, but would return an incorrect value for the give conditions. With the DVOM still connected, the EGR valve connector and FRP sensor connector were disconnected. VREF remained at 3.7 Volts.

This diagnosis correctly classified the fault as a short in VREF circuit. Diagrams showed the VREF circuits to be in parallel, and while they didn't prove that all VREF circuits in the PCM were shared, the codes made the connections for us. Since VREF wasn't pulled all the way to ground, it was more likely a sensor fault than a wiring fault, but the best tools and tests were the same: Use a DVOM to measure VREF while disconnecting components and harnesses that share it, starting with the most accessible sensors. While the eventual repair included dropping the tank, the diagnostic process worked, so the tank R&R could be sold as a solution, and not an unbillable guess.

The FTP sensor was disconnected, and the VREF jumped to 5 Volts at the FTP connector as well as at the A/C pressure sensor and every other sensor tested. All other sensors were reconnected, and all sensor signal PIDs (including A/C pressure) returned to normal. The FTP sensor was replaced and the vehicle was returned to the customer.
