FirstLook[™] vacuum waveforms showing the effect of a worn cam and lifter in a Safari van

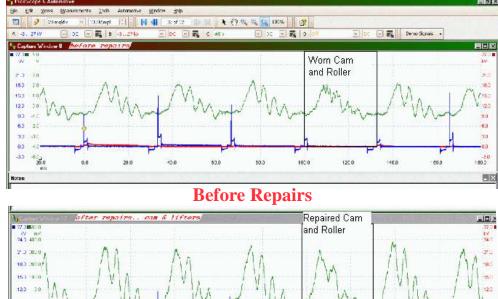
Photo of parts replaced showing cam and roller damage.

Cam and lifters were replaced. Waveform still shows some effects that engine miss has had on valve seat. With a cleaning and normal running this should return to normal.
